Evaluating and Maintaining the Decentralized Wastewater Treatment system at Sowl Kere

1.2 Decentralized Wastewater Treatment System (DTS)

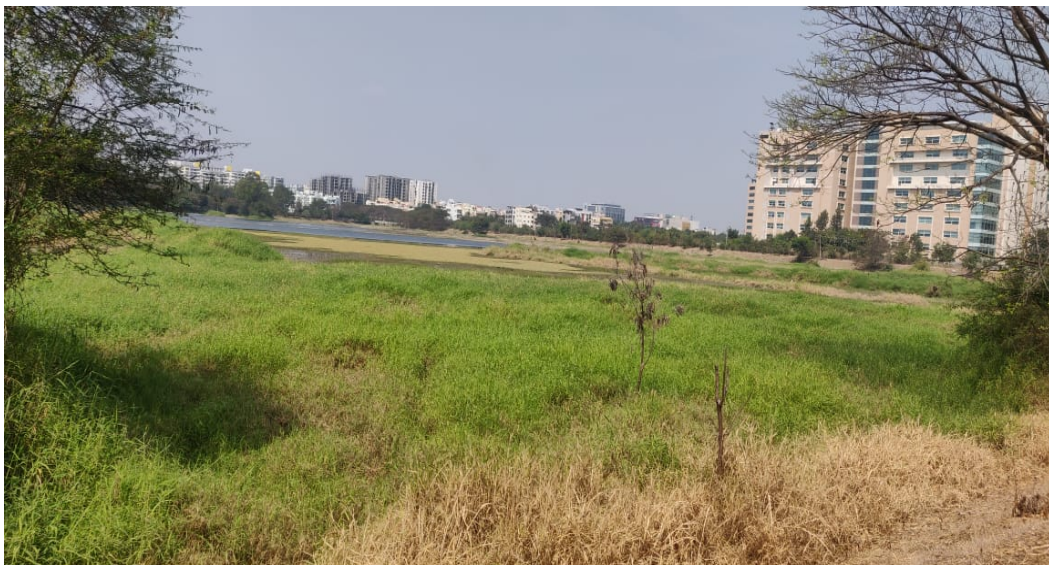
Fig 1: View of Sowl Kere from the eastern bank (15 Feb 2022)

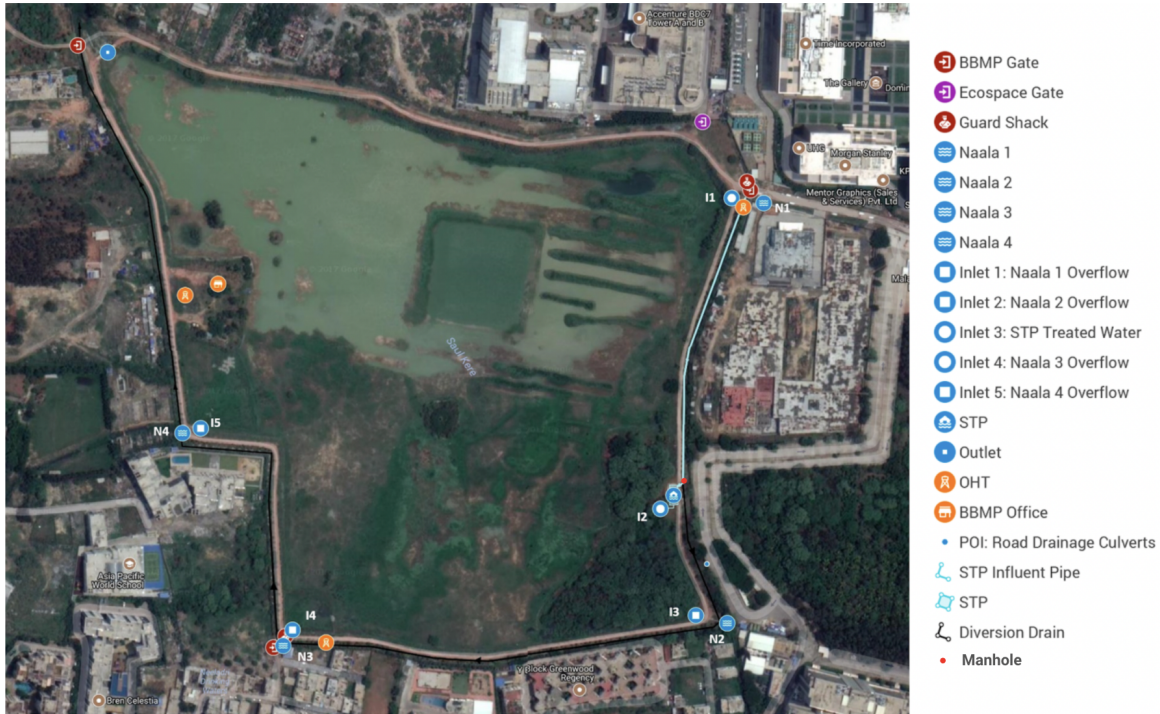
Fig 2: Sowl Kere Lake Map

(Note: In the map, N - naala and I - Inlet as corresponding with the legend)

A manhole helps direct water from the eastern diversion drain to the STP through a culvert (marked in Fig 2 near the STP). Accumulated sludge and solid waste were cleaned from this manhole to maintain proper flow.

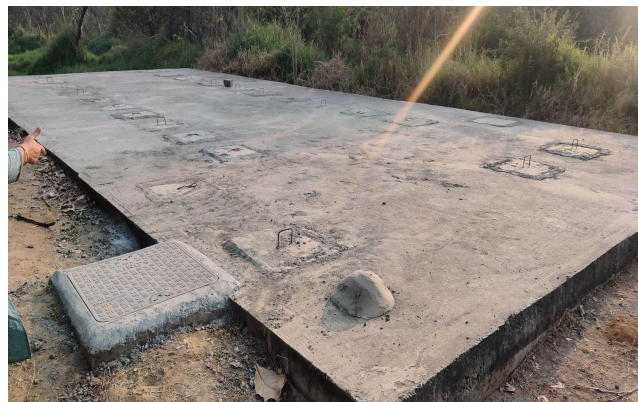
A natural, self-sustaining and zero/low maintenance STP - Decentralized Wastewater Treatment System (DTS) - was designed and implemented by Eco Paradigm through CSR funding in 2016. This system was designed to treat 100 KLD of sewage from the Eastern diversion drain. A culvert was built to get the water to the lakeside at I2 (see Fig 2) from the diversion drain. Post the treatment, treated wastewater first entered the wetland area and then the water spread area.

Fig 3: The Decentralized Wastewater Treatment System

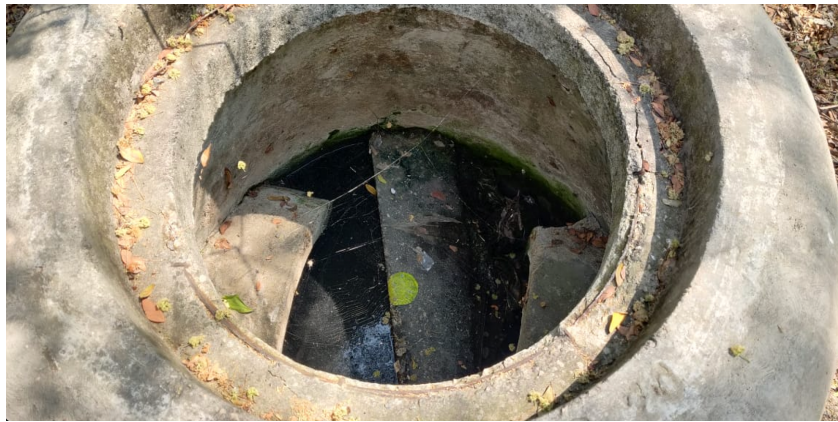
Fig 5: Manhole after cleaning

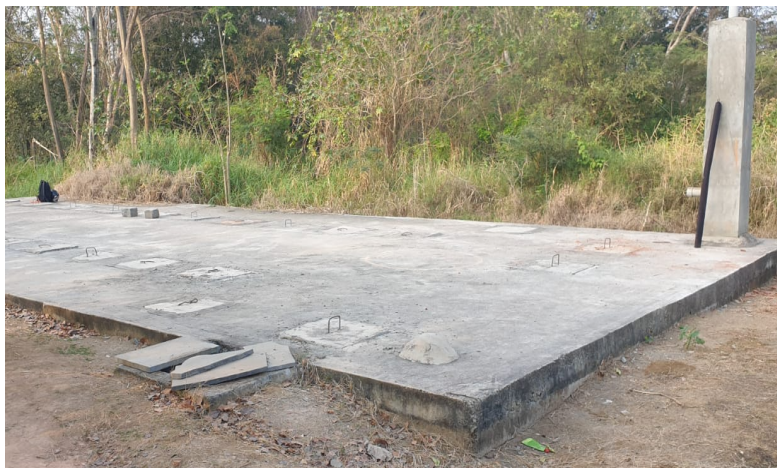
The inlet opening in front of the DTS was clogged and its cement lid was broken. This was unclogged and a stronger FRP (Fibre-reinforced Polymer) lid was used to cover it.

Fig 6: Broken inlet before intervention

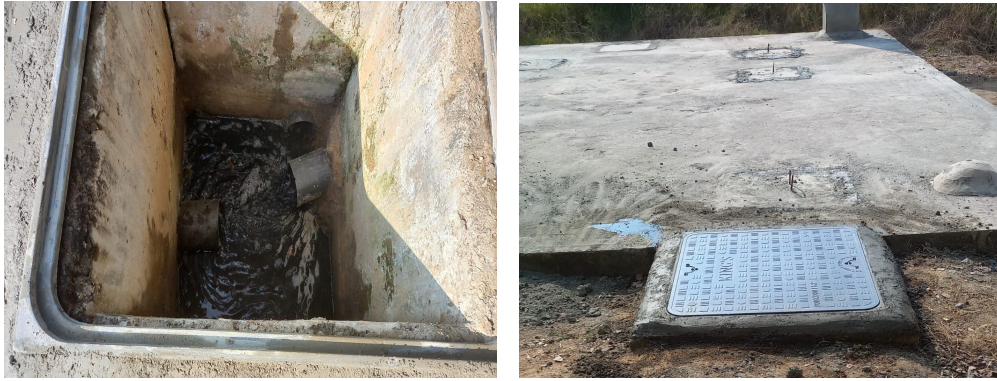
Fig 7: Inlet unclogged (left) and FRP sheet top lid for the inlet (right)

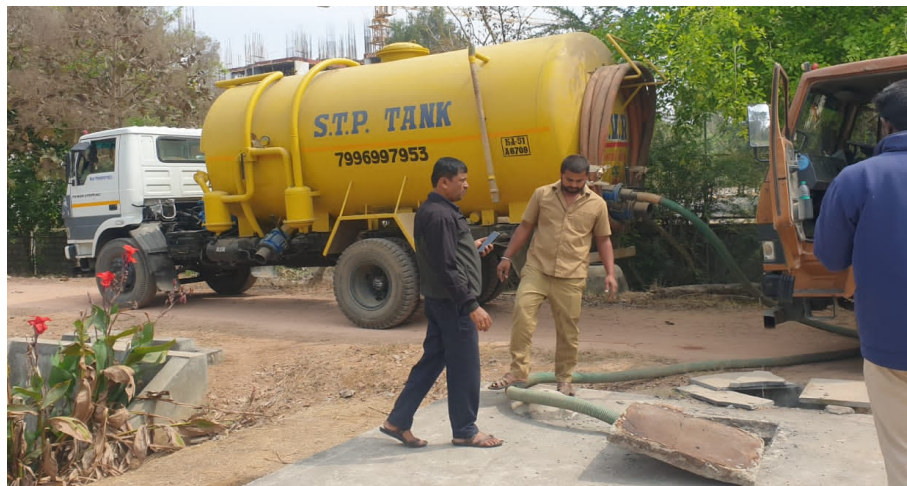
Fig 8: Sludge removal from the DTS

Cleaning involved desludging and removal of solid waste. Six tankers of sludge mixed with some amount of solid waste were removed. The cost of removal and transport for each tanker was Rs 16,000. The sludge was to be taken to Anekal, where the plastics were to be separated out and the sludge distributed to farmers. We assume that this would have been carried out responsibly.

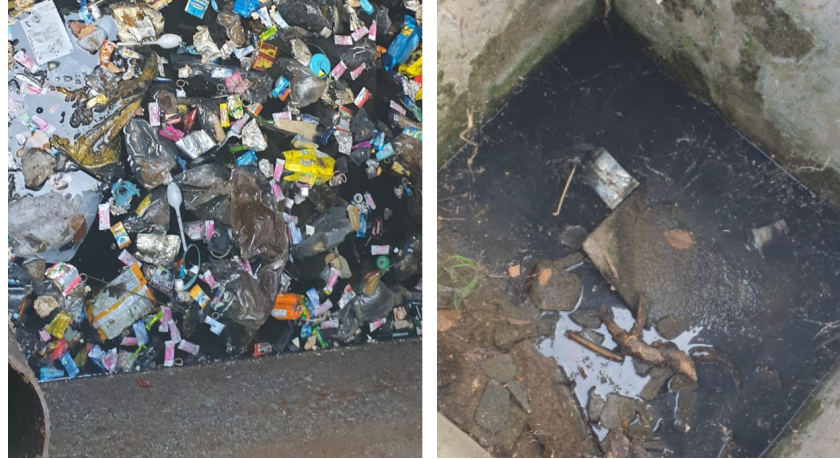
There are 24 manholes to access different parts of the DTS, whose lids were cemented shut for safety reasons. All these manholes were broken open and cleaned thoroughly which ensured that all parts of the STP were cleaned.

Fig 9: Manholes filled with plastic and sludge

Currently, the 24 manholes on top of the DTS need to be broken open and cemented back to close them. Since at a minimum, desludging is essential at least once a year, this can be very inconvenient and resource extractive. A lid that could be opened and closed easily would help access the DTS better. This could be a conventional cement lid, an iron lid or an FRP lid similar to the one mentioned in section 2.2.

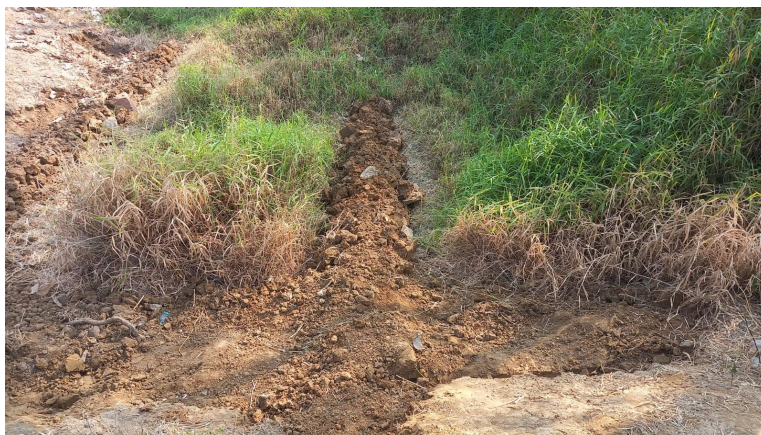
Fig 10: Pipeline supported and covered with soil

Apart from this, the pipes had to be better supported at the bottom to avoid bending/breaking caused by the weight of the water passing through them. This was achieved by packing soil beneath the pipes. Soil was also laid on top of the pipes to cover them. This was done to avoid damages due to any impact from the top.

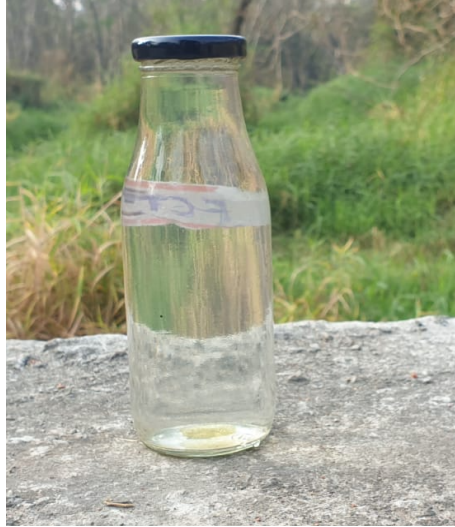
The perceived quality of the outlet water was clear and odourless. The lab report can be found in Fig 13.

Fig 12: Water from the outlet

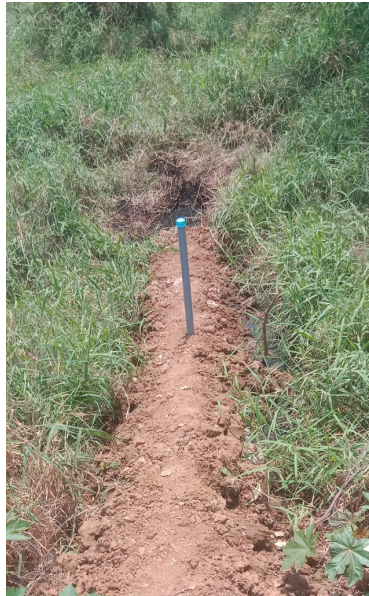
Fig 14: Pipe markers along pipeline

Marking the location of the pipes that were covered with soil was necessary to help identify their location for future maintenance. This was also done to avoid any damages to the concealed pipes that might occur due to other work undertaken in the area. Pipes with painted tops were used as markers along the length of the concealed piping at regular intervals to identify the location.
